National Dam Inspection Program,
Little Buffalo Creek Dam, Susquehanna
River Basin, Commonwealth of
Pennsylvania, Perry County (NDS-PA-582),
Phase I Inspection Report.

LITTLE BUFFALO CREEK DAM

PHASE I INSPECTION REPORT

NATIONAL DAM INSPECTION PROGRAM

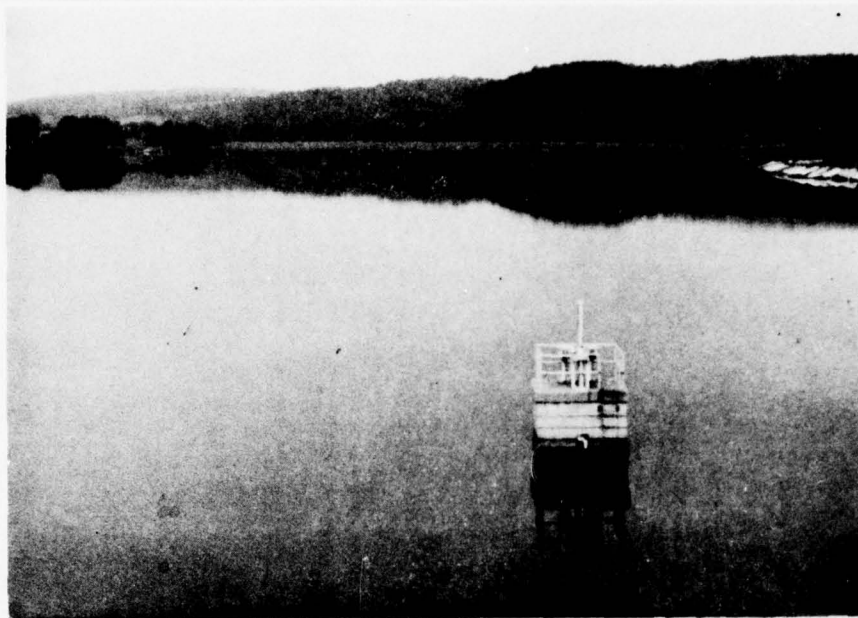
Access to the intake tower is by boat. The visual observations indicate that this structure and its gate and valves are in good condition. The 36-inch sluice gate was opened and closed for this inspection. It is noted that the deck of the tower is below the crest elevation of the dam (515.5 vs. 500.0).

Reservoir and
Intake Tower

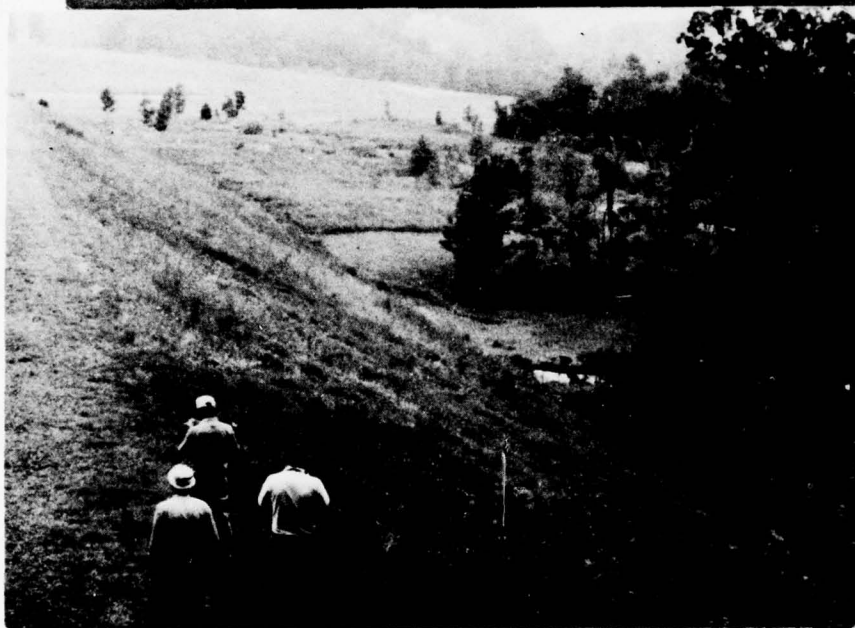
There is concern for the wet spots detected on the downstream slope and the apparent high volume discharge in the toe drain.

There were no signs of distress visible on any of the slopes. Sloughs, cracks, settlement or serious erosion were not evident. The riprap on the upstream slope appeared to be in good condition.

Downstream Slope

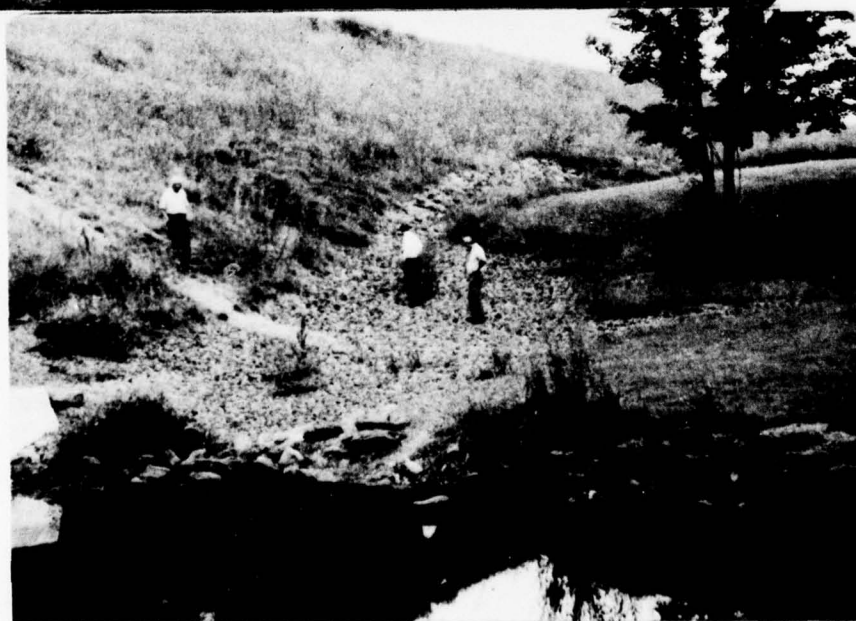
The overall condition of this facility, on the basis of this visual inspection appears to be good. The major concern is the apparent volume of the leakage at the downstream toe of the embankment and the wet spots noted on the slope above the outlet structure; both to the left of the outlet structure.

Inspection reports in 1973, 1974 and 1975 mention a seepage condition on the downstream slope. The records of 1976 indicate the need to repair a weir that was used to measure leakage from the dam. This apparently refers to the weir observed at the end of the plunge pool downstream from the outlet structure. Although these records are not complete, they indicate that there has been an ongoing seepage condition near and to the left of this structure.

Examination of the construction drawings, the test boring data and the geologic setting of this dam indicates that the rock formations are subject to leakage along the bedding planes and fractures. Since grouting was carried out in the foundation formations beneath the south abutment and beneath the spillway, the condition was noted and accounted for in these areas. The reason for partial treatment of the foundations is not described in any of the available records. It suggests that the leakage may be coming from the foundation formation which has not been grouted.

Toe Near
Conduit Outlet

1. That the weir in the outlet channel be restored to operating condition.
2. That the seepage from the toe drain be monitored on a regular schedule. If changes in volume or clarity of the discharge occur, a detailed investigation should be carried out and if conditions warrant, remedial action taken as necessary.
3. A study be made to determine the nature of the seepage problem on the downstream slope to determine the long time effect on the safety of the dam. Necessary remedial action shall be taken as required.

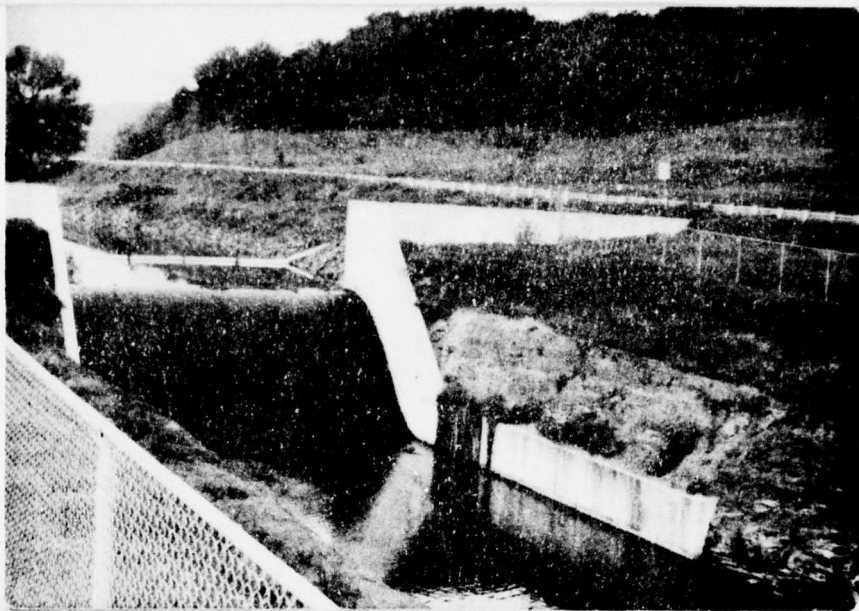
The concrete forming the spillway, emergency spillway, and wall is all in good condition. Water was barely spilling over the primary spillway crest at the time of this inspection. The maximum flow reported for this dam was 4.9 feet over the spillway during the 1972 storm, Agnes. This flow did cause some damage to the spillway outlet channel. This damage was subsequently repaired in March, 1974 when a permit was issued to draw the lake down for this purpose.

The spillway and its outlet appear to be in good operational condition. There is a staff gage mounted on the left wall of the spillway weir.

Spillway and
Emergency Spillway

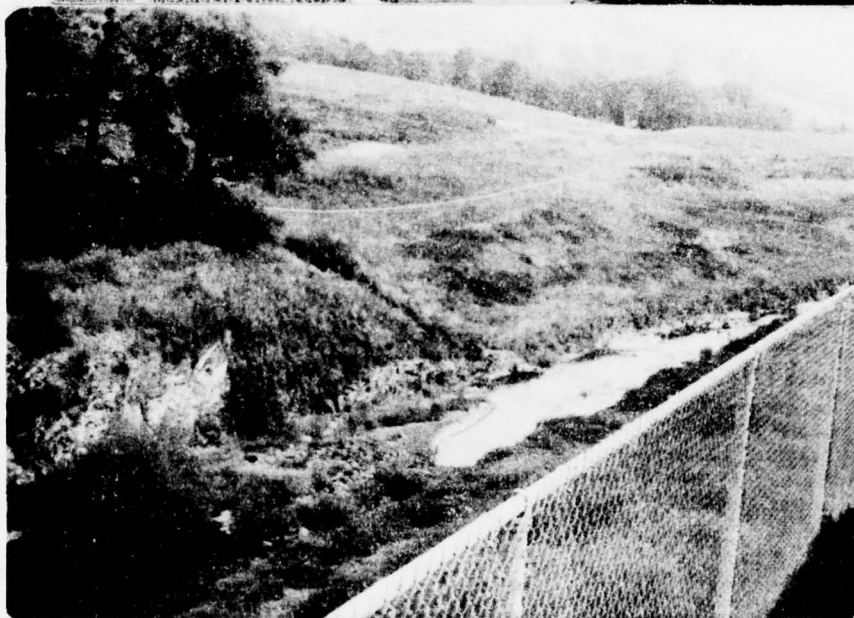
There was no damage from that flood with the exception that some of the weathered slate in the unlined spillway chute was torn loose.

Spillway Channel
Looking Downstream
